# Technical Bulletin

01 07 69 Dec. 13, 2007 2016182 Supersedes T.B. Group 01 number 07-64 dated Oct. 1, 2007 due to corrected part number in Required Parts and Tools field.

**MIL ON, DTC P129F and or P310B Stored in ECM Fault Memory**

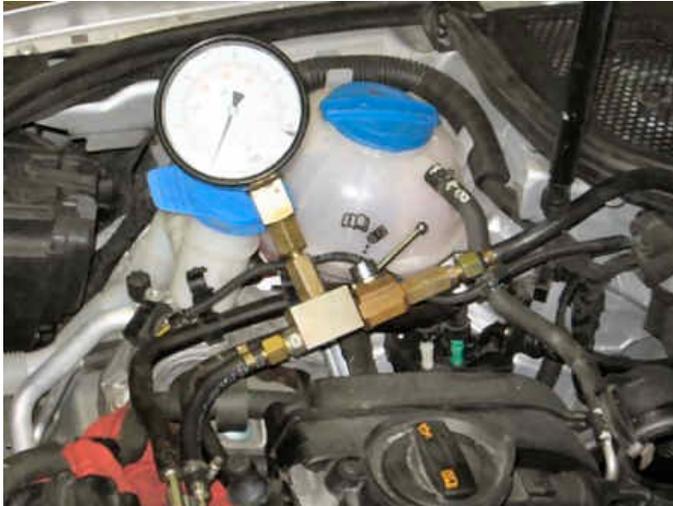
**Figure 1**

To verify low side fuel pressure, a mechanical fuel pressure gauge may be connected in the engine compartment (figure 1).

- Add 1 bar (14.5 psi) to value obtained from mechanical gauge to calculate adjusted gauge measurement.
- Compare adjusted gauge measurement to value stored in MVB 103 field 1.

VAG 1318 gauge installed on a 2.0T FSI vehicle.

MVB 103 field 1 value should be approximately 1 bar (14.5 psi) above mechanical gauge reading. This is a normal condition and **does not** indicate a faulty sensor.

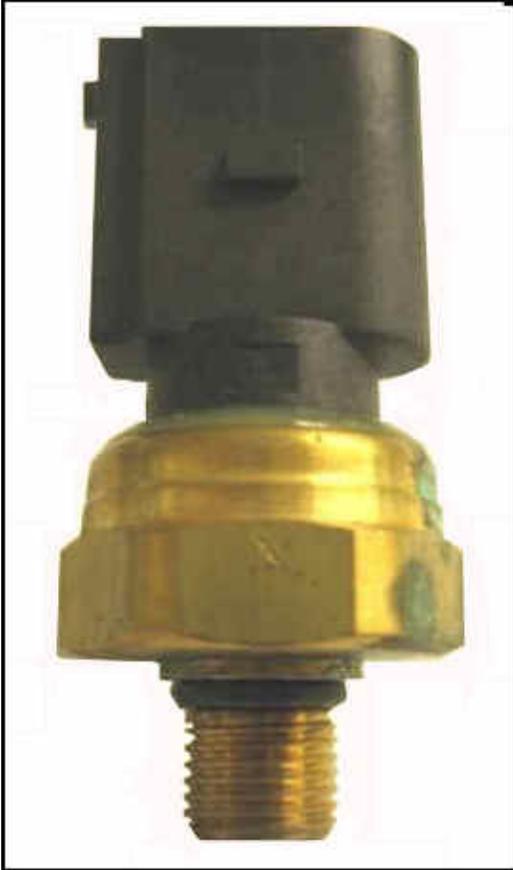
Figure 2

2.0L (BPY) Fuel pressure sensor

Part No. **06E 906 051 J.**

3.6L (BLV, BHK) Fuel pressure sensor

Part No. 03C 906 051A.
