Technical Bulletin

Model(s)	Year	Eng. Code	Trans. Code	VIN Range From	VIN Range To
Touareg	2004 - 2007	All	All	All	All

Battery, Testing, Charging Using Midtronics MCR340V Battery Analyzer or InCharge 940 (INC-940) Battery Charging Station

27 07 02 Jan. 22, 2007 2012377 Supersedes T.B. Group 27 number 06-05 dated Oct. 6, 2006 due to additional starter battery information.

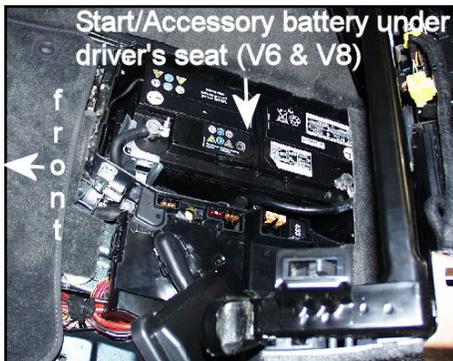
Start/Accessory battery

- Select Standard (Lead-Acid) for 3.2L, 3.6L, and 4.2L engines (located under driver's seat). **450 DIN***

* Always verify using DIN rating as shown on battery label.

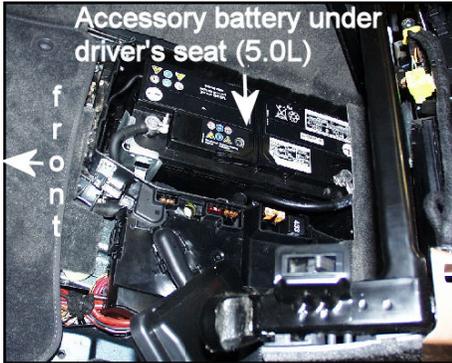
Accessory battery

- Select Standard (Lead-Acid) for 5.0L (TDI) engine (located under driver's seat). **520 DIN***

* Always verify using DIN rating as shown on battery label.

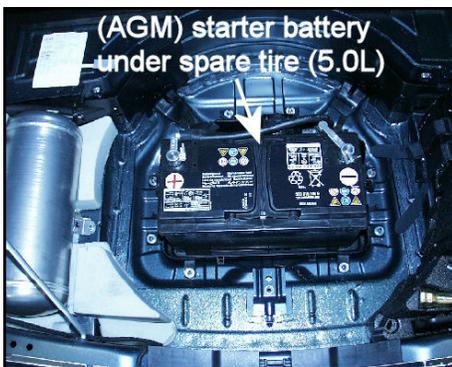
Starter battery

- Select AGM (Absorbed Glass Mat) for 5.0L (TDI) engine (located under spare tire). **480 DIN* or 520 DIN***

* Always verify using DIN rating as shown on battery label.

The starter battery must be checked independently of the accessory battery.

The starter battery cannot be tested or charged via the remote location in the engine compartment. To test or charge the starter battery, go directly to the battery terminals.

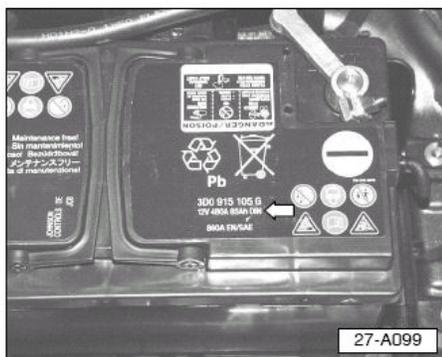
- Always use actual DIN rating as shown on battery label -arrow-

Label shown is for example only. DIN or SAE specifications may vary from battery to battery.

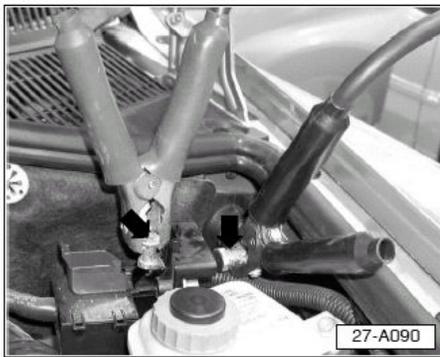
When using remote location terminals -arrows-, located in the engine compartment, always reduce DIN rating on MCR340V or INC-940 testers.

3.2L, 3.6L, and 4.2L engines: **270 DIN**.

5.0L (TDI) engine: **295 DIN**.

The use of these reduced DIN ratings are required to compensate for the internal battery manager and/or the extended length of cable due to the battery location.

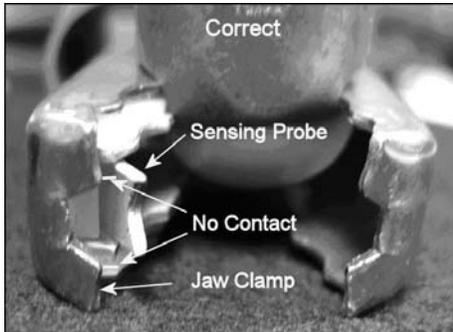
- There must be no contact between the inside connection and the outside jaw of the clamp, -arrows- as shown.

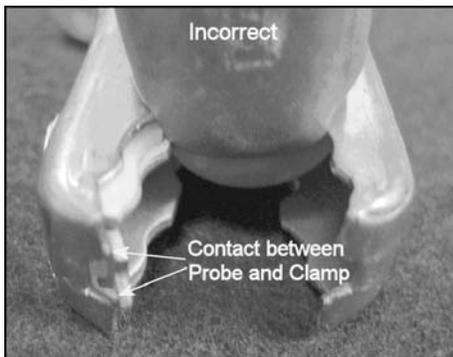
The INC-940 may always display the message to “Check Connections” after cables are connected to the battery terminals.

This is most likely due to the sensing probe making contact with the clamp.

- Inside connection is bent and touching the outside of the clamp, -arrows- as shown.

- Use a small flat tool and gently bend the sensing probe so it does not make contact with the clamp.

- Contact Midtronics Corporation Customer Service Department at 1-800-776-1995 for assistance.
