Technical Bulletin

Model(s)	Year	Eng. Code	Trans. Code	VIN Range From	VIN Range To
Touareg	2004 > 2007	All	All	All	All

87 07 06 Apr. 24, 2007, 2014813

HVAC, Ticking Noise Behind Dash Panel or Center Console

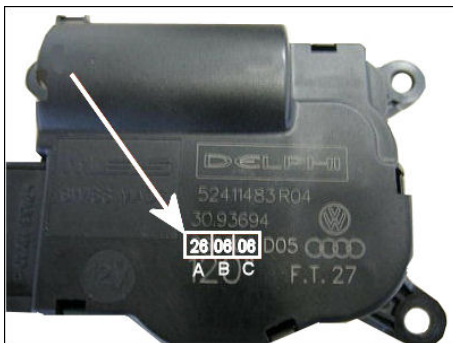
Flap/Vent Motor Identification

The -arrow- highlights the following manufacturing information:

A = Production Day

B = Production Month

C = Production Year

Production date on this flap/vent motor is 260606 (June 26, 2006).

- Replace only the flap/vent motor causing the ticking noise. See [Required Parts and Tools](#). Replace with a flap/vent motor produced after 100906 (September 10, 2006). See **Flap/Vent Motor Identification** below.
See Repair Manual, Heating, Ventilation & Air Conditioning, 87 Air conditioner.
- Perform Basic Setting of flap/vent motors once repair is complete.
See Repair Manual, Heating, Ventilation & Air Conditioning, 87 Air conditioner.

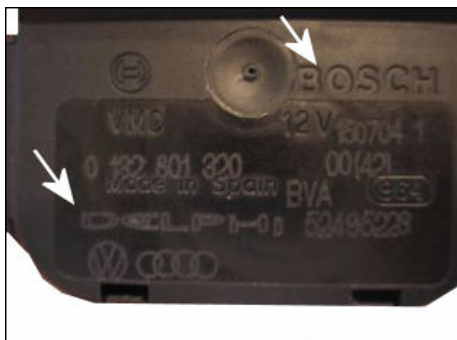
BOSCH/Delphi -arrows- manufactured flap/vent motors are not affected.
DO NOT replace flap/vent motors manufactured by BOSCH/Delphi.
