Volkswagen TOUAREG

REPAIRING central ARMREST

Repairing the central armrest

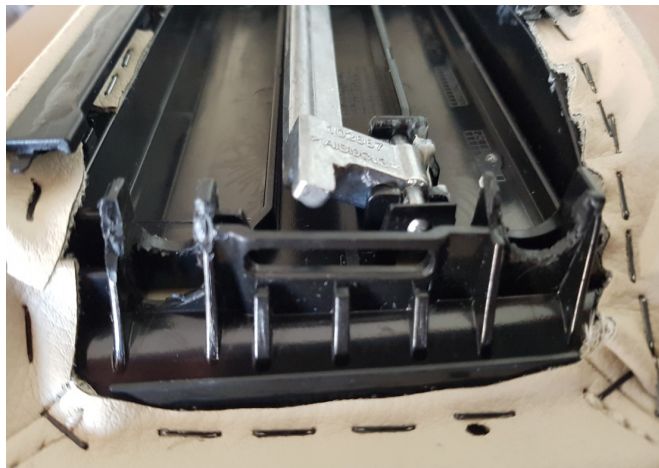
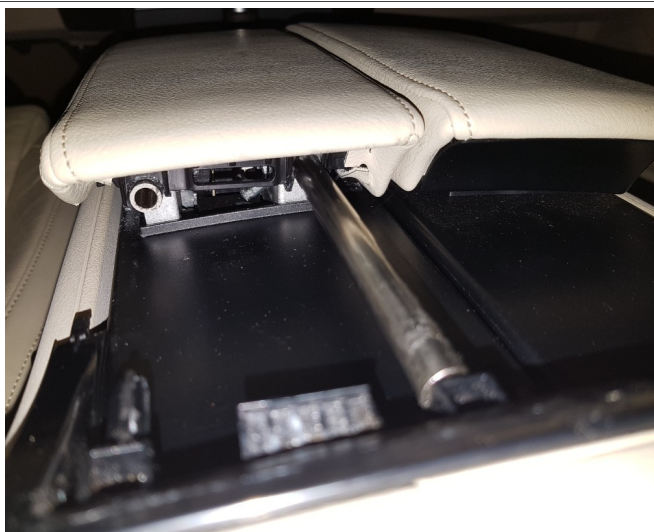
Situation: driver side, broken parts were not present inside.

The normal method to disassemble the device is to first pull the back plastic panel (blue arrow), while slightly pulling down the middle tab as indicated in red.

The back panel is a bit hard to extract from the slide tube, but it should come out (green arrow).

Notice the presence of glue on this panel, which did not have any effect (should have been glued on leather !)

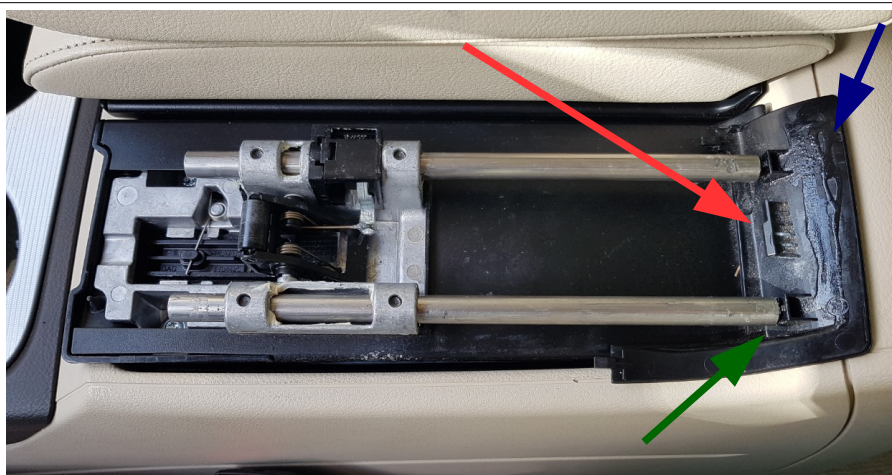
Passenger side (right), once opened and broken.

You can see 2 Orings on the free slide tube.

The master tube (managed by the lever mechanism) has none.

The tubes are made of stainless steel, which is not so bad.

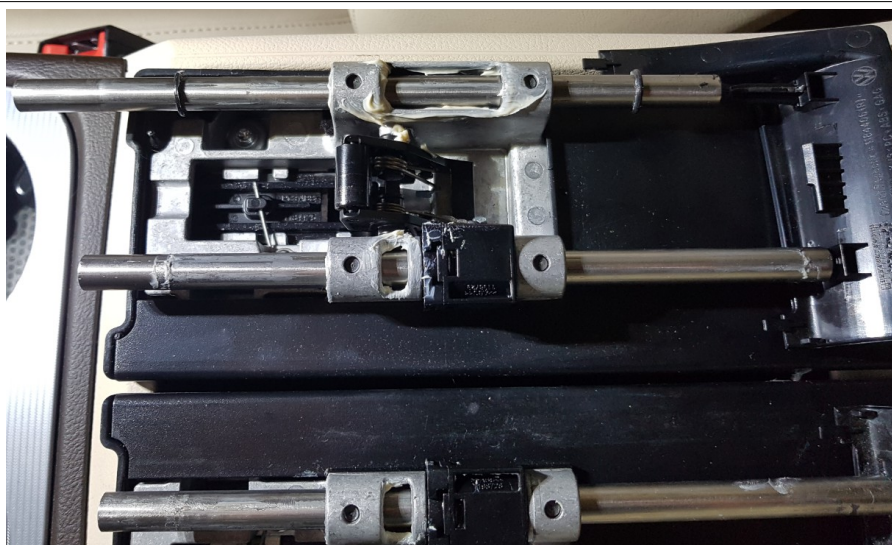
One side fully broken

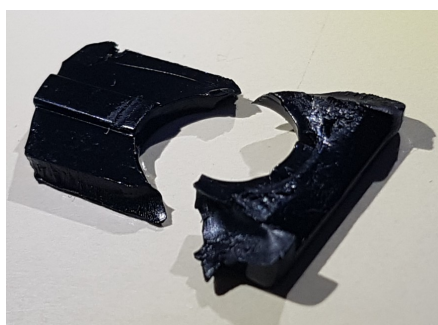
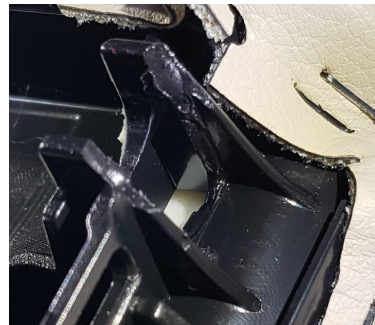
The other side is also slightly broken

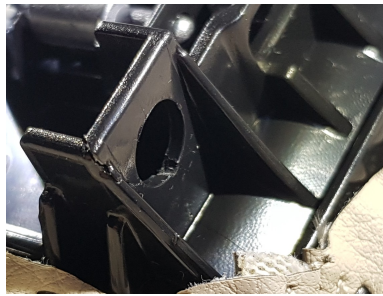
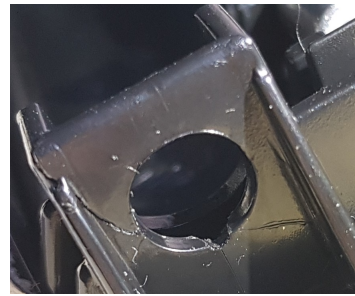
Slide tube seems to be a bit too long (207,86mm) to fit inside the plastic body (I have measured 207,5mm) without forcing. This can crack the small back side wall.
Tubes have not the same size, some are 208mm long.

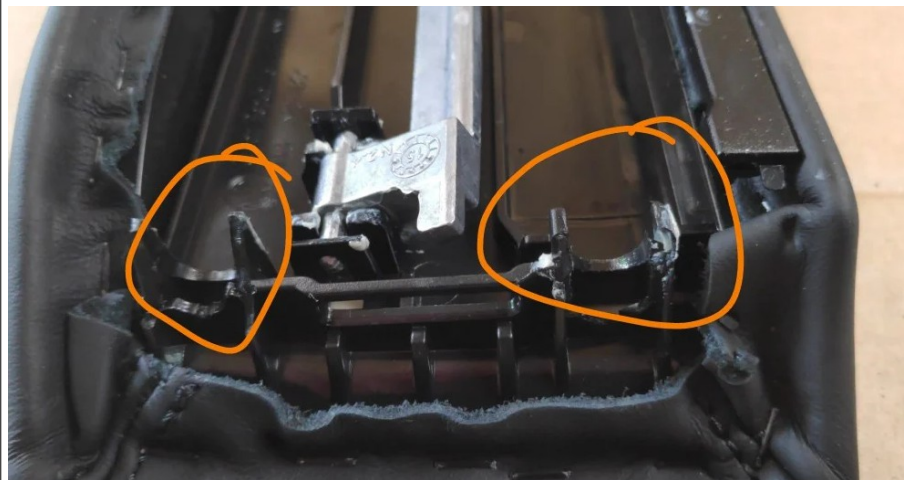
Another user's issue: the same problem
[\(1\) Replace right hand side, centre console, split armrest on 2015 3 litre TDI P7 | Club Touareg Forum](#)

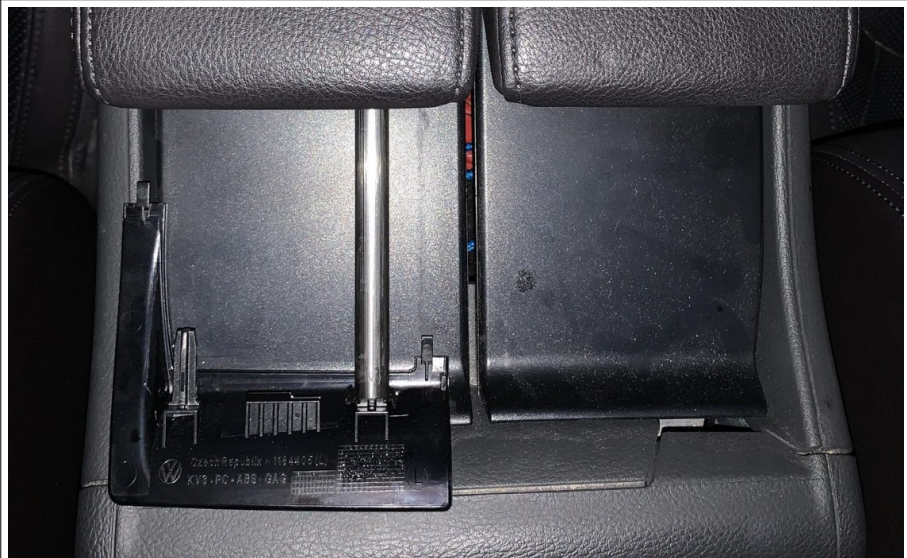
Another one.
