Technical Bulletin

91 07 05 April 25, 2007 2010411 Supersedes T.B. Group 91 number 05-01 dated May 3, 2005 due to inclusion into ElsaWeb.

Radio, Reception Diagnosis

Poor radio reception.

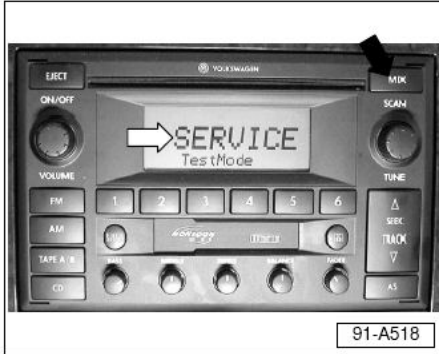
Premium VI radios are capable of signal diagnosis through operating internal diagnostics of the radio unit.

All models except Touareg and Phaeton:

- Select AM or FM.
- Press and hold the mix button (black arrow).

Screen will appear that shows "Service Test mode" (white arrow).

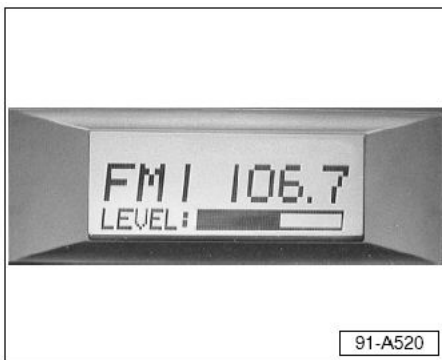
Screen displays strength of signal (LEVEL) in bar graph form (can be used for AM and FM).

- Press mix button briefly again.

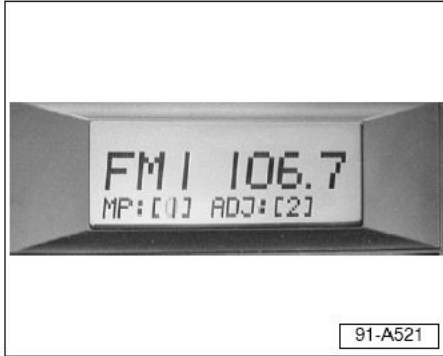
Screen indicates number of stations broadcasting close to frequency band of selected station.

As the number increases for [mp] and [adj], static and signal crossing will increase.

To exit service mode:

- Press and hold the mix button or switch radio OFF then back ON.

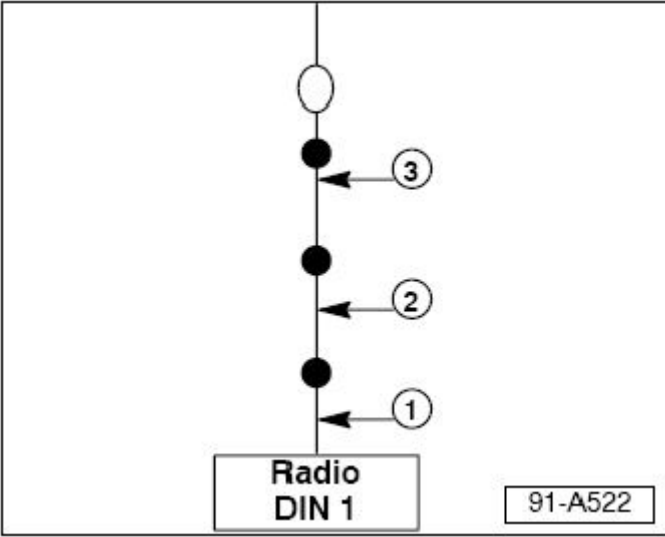
<p>If antenna cables are required:</p> <p>Antenna cables - single DIN (Premium V) radio.</p> <table> <tr> <th>Location</th><th>Part No.</th></tr> <tr> <td>1</td><td>000098696</td></tr> <tr> <td>2</td><td>000098655</td></tr> <tr> <td>3</td><td>000098698</td></tr> </table>	Location	Part No.	1	000098696	2	000098655	3	000098698
Location	Part No.								
1	000098696								
2	000098655								
3	000098698

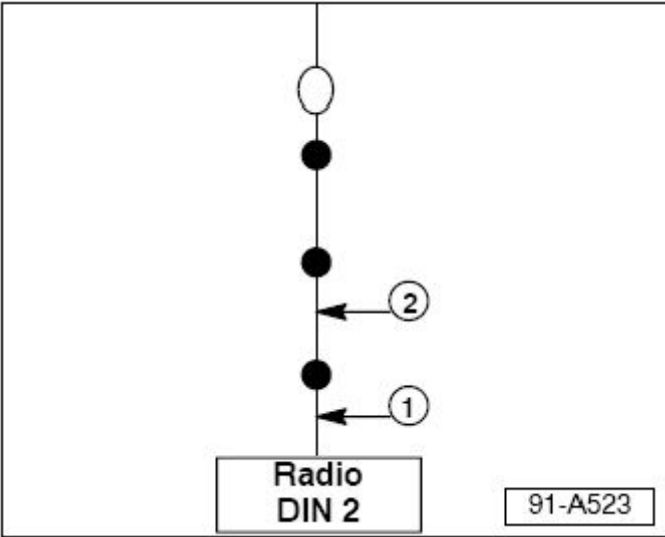
<p>Antenna cables - double DIN (Premium VI) radio.</p> <table> <tr> <th>Location</th><th>Part No.</th></tr> <tr> <td>1</td><td>000098655</td></tr> <tr> <td>2</td><td>000098698</td></tr> </table>	Location	Part No.	1	000098655	2	000098698		
Location	Part No.								
1	000098655								
2	000098698
